Agenda Item #3

Application 2024-48-CA

456 Chatham Street

After-the-fact approval for exterior repairs and alterations

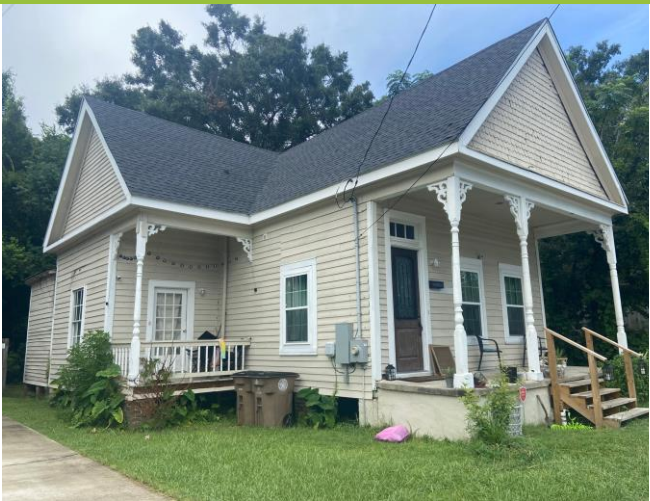
1. View of dwelling, looking NW

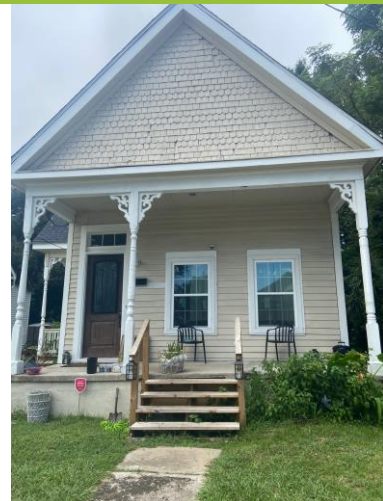
The *Guidelines* state that replacement doors should reflect the age and style of the building. The new primary door installed on the façade is not suited to the style of the dwelling. The replacement doors on the side projection and the rear elevation are not wood , which was the listed door material in the approved scope of work. (5.15) The *Guidelines* direct to preserve architectural details and ornamentation such as turned columns and brackets, and to replace such details accurately. In specific regard to porches, the *Guidelines* state that a porch should be repaired in a way that retains its original character. Photos and site visits revealed that a turned post was removed from the front porch and has not been replaced. Additionally, the existing concrete steps were removed and replaced with raw wood steps and handrail of a design which is not compatible with the front porch's historic character. (5.17, 5.19, 6.5)

2. View of façade, looking W

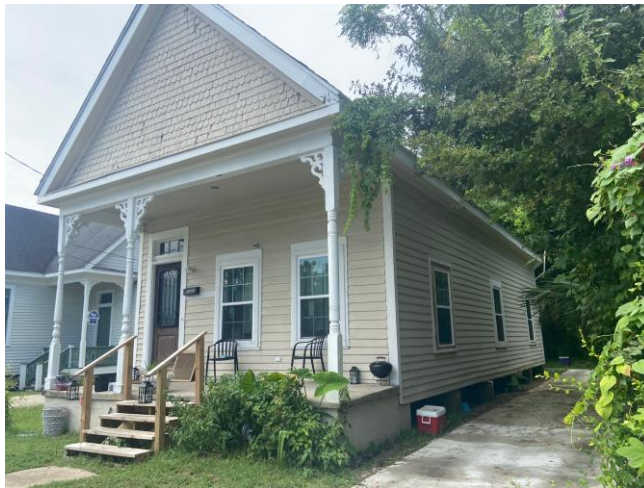
3. View of façade and north elevation, looking SW

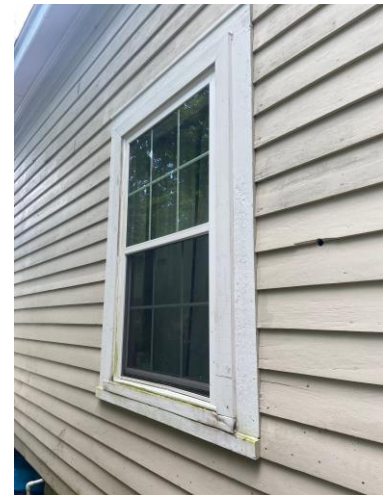
The *Guidelines* stipulate that historic windows should be repaired rather than replaced, wherever possible; that they should be repaired to match existing per location, light configuration, detail and material; and that all features should be preserved. When repair is not possible, a replacement window should be matched to the original in framing and light configuration, and should fit within the original opening and match the depth and profile of the reveal. The *Guidelines* further list vinyl as an unacceptable material for replacement windows. (5.21-5.22) According to available records and photographs, the windows which were replaced on the dwelling were a combination of historic and original. A survey photograph dated 1989 show twelve-over-twelve windows on the façade. This configuration seems unlikely for a house with a construction date of c. 1894; however, these windows were assuredly historic. The remaining windows had a six-over-six light configuration. Photographs further reveal that these windows were still extant when the property was sold in 2019. Photos taken during the Staff visit in 2022 show historic windows and doors discarded on the property. Although there was no window survey completed to document the condition of the historic windows, the scope of work from the 2018 issued COA details the repair of existing windows, with no mention of replacement. This implies that the windows were not beyond reparable condition. The installed replacement windows are a vinyl six-over-six sash, which does not fit the existing window openings. Wood trim infill has been installed to fill the openings. However, this has been done in an inconsistent manner across the elevations and has not been finished, with some of the trim remaining unpainted.

4. Detail of window on north elevation

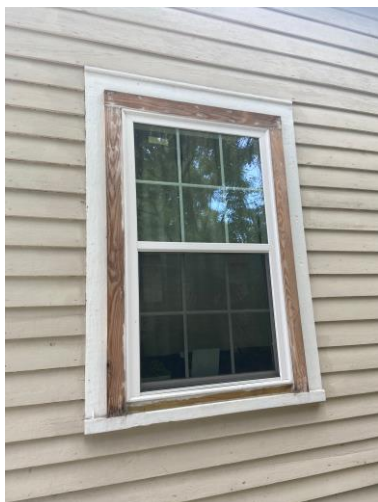
5. Detail of window on north elevation

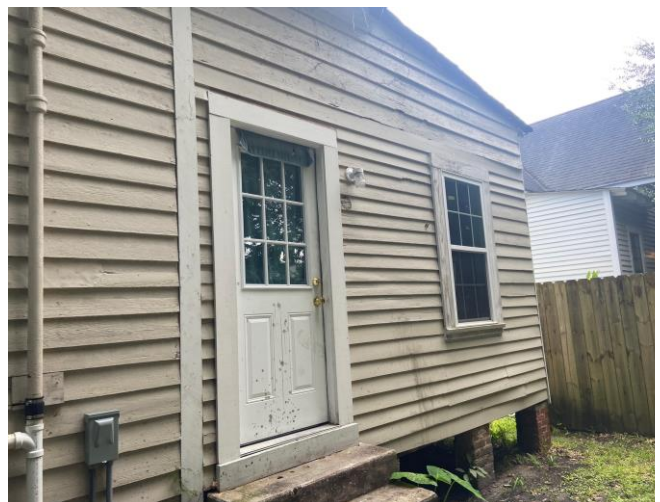
6. View of rear elevation, looking SE

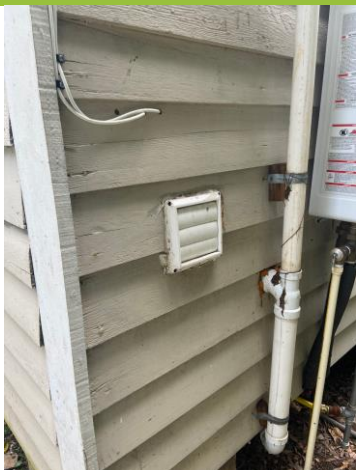
7. Detail of rear elevation

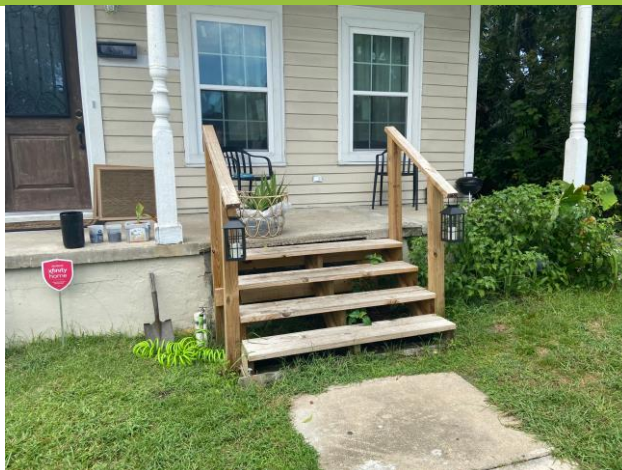
8. Detail of porch steps
