# Agenda Item #1

## Application 2024-42-CA

1259 Selma Street

Fenestration changes; installation of iron railing.

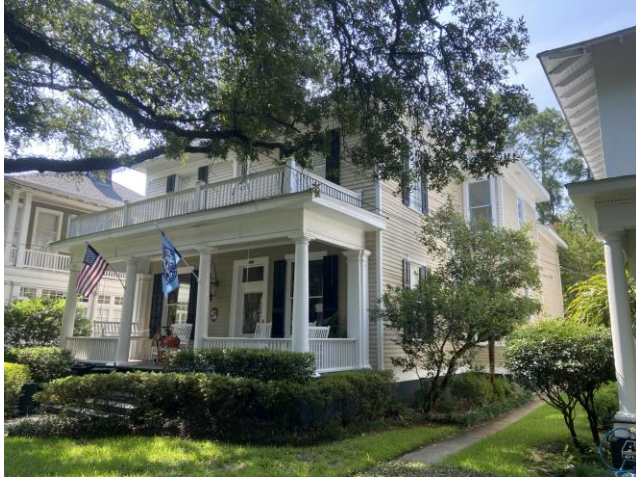
1. View of façade and west elevation, looking SE

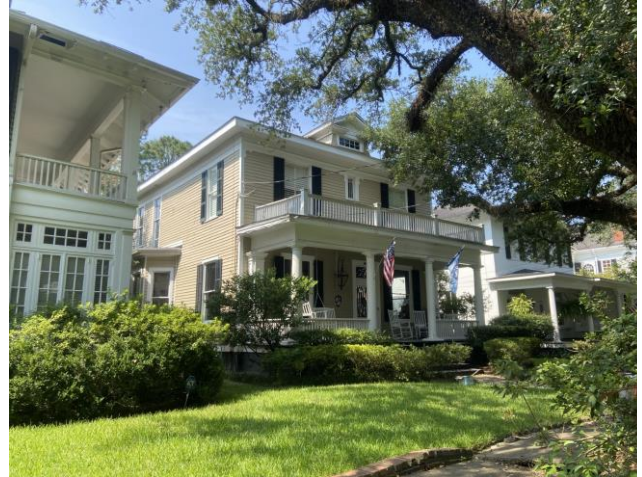
2. View of façade and east elevation, looking SW

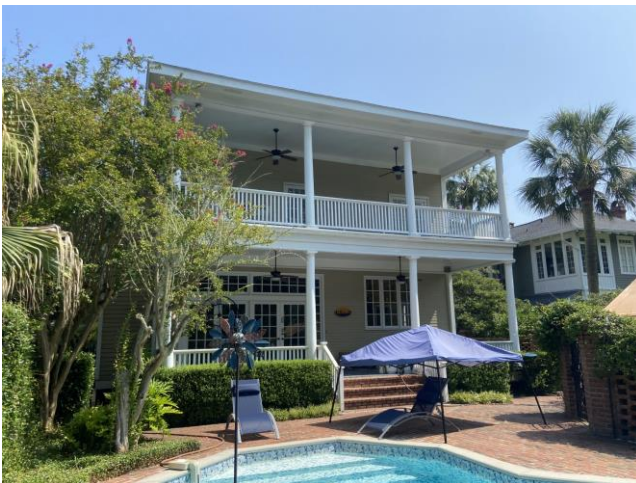
3. View of south (rear) elevation, looking N

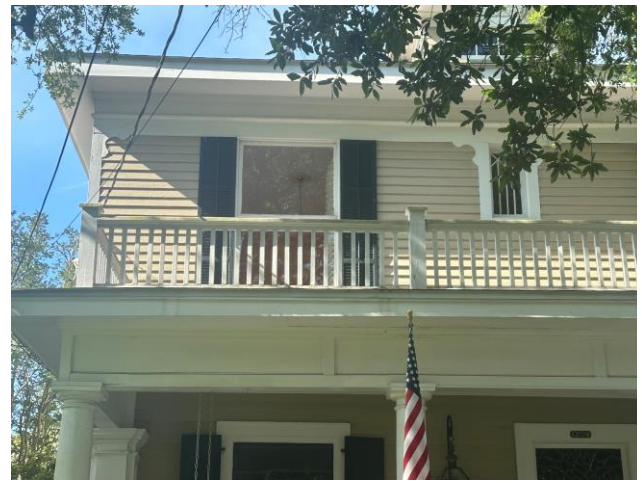
The *Design Review Guidelines for Mobile's Historic Districts (Guidelines)* state that original windows should be repaired and retained, and their character-defining features preserved to the extent possible. (5.20) The original windows proposed for replacement at 1259 Selma are large one-over-one sash windows located on the north and south ends of the second-story of the façade. The proposed custom wood replacement doors would fit the window openings and mimic the one-over-one light configuration. The existing windows have been painted shut, and the pulley mechanism which operates the sash has been cut, rendering the windows inoperable and creating a safety issue. Paint is chipping and peeling in places. However, the windows are not in irreparable condition and could be fully restored and operational with minor repair work. Although the replacement doors echo the design of the original windows and would resemble windows from the street, the submitted drawings show the profile of the dividers to be slightly thicker and wider than those of the existing. Additionally, the doors would incorporate a vertical divider that is not present on the existing one-over-one windows. (5.21)

4. Detail of second story original window, submitted by applicant

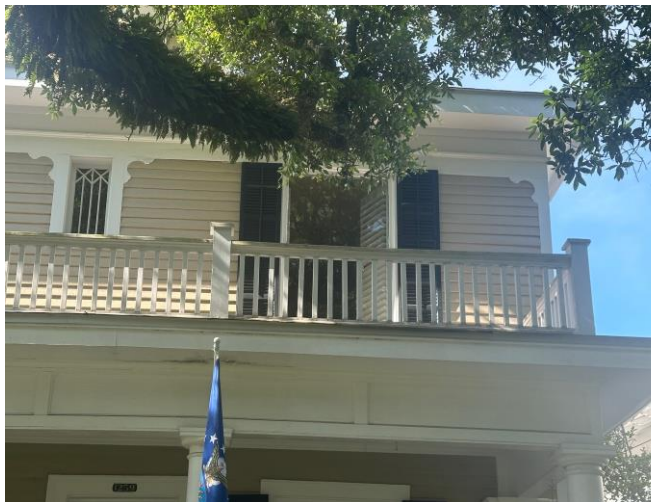
5. Detail of second story original window, submitted by applicant

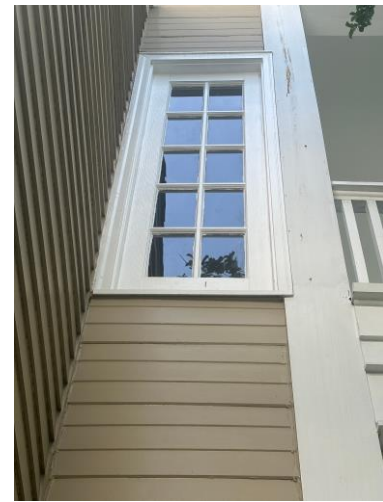
6. View of non-historic casement window on west elevation of addition, submitted by applicant

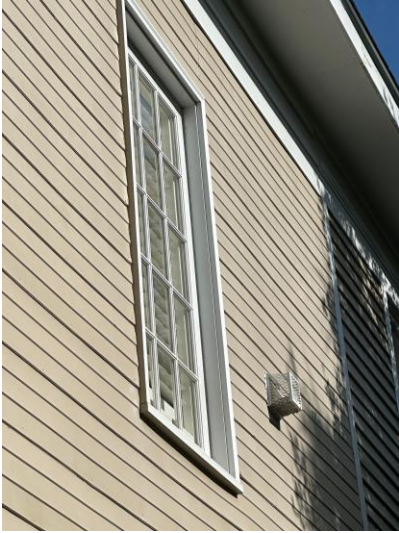
**7. Detail of non-historic casement window on east elevation of rear addition, submitted by applicant**

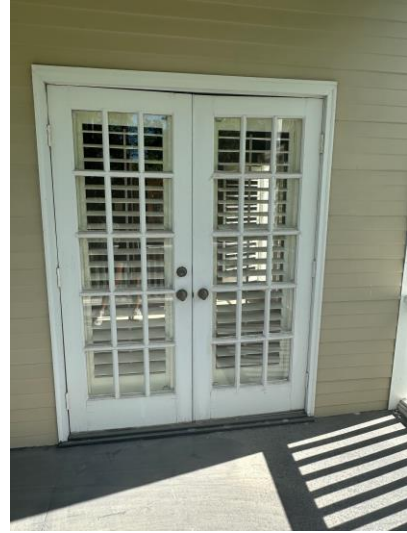
The remaining doors and windows proposed for replacement in the subject application are located on a rear non-historic addition. Two sets of French doors positioned on the north and south ends of the west (rear) elevation's second story have deteriorated due to moisture and no longer fit the opening. Two multi-light fixed windows, one on the west end of the north elevation and the other on the west end of the south elevation, show signs of rot and cracking. In regard to additions, the *Guidelines* call for doors and windows to be designed in compatibility with the existing historic building and the district. This compatibility applies to materials, scale, and profile. (6.16, 6.21) The traditional multi-light design of the existing wood French doors and fixed windows are well-suited to that of the original structure and are complementary in scale to original door and window openings. The proposed replacements match the existing and therefore would not disrupt the current compatibility.

**8. Detail of second-story non-historic French doors on rear elevation of addition, submitted by applicant**
