Application 2024-56-CA

252 Rapier Avenue

After-the-fact: 1. Replace window on second story façade with double doors that do not fit the opening.
2. Replace balustrade above front porch.

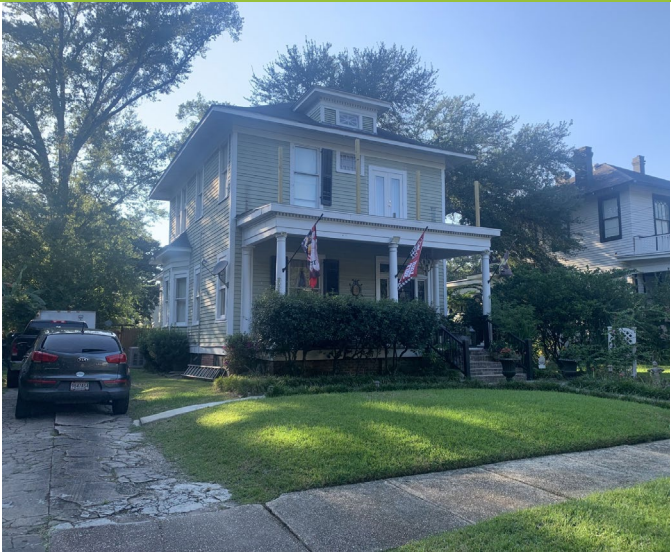
1. View of property, looking NW

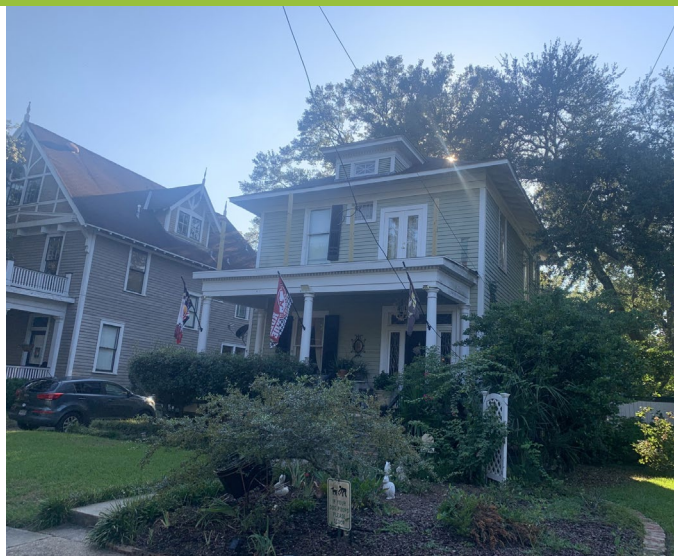
2. View of property, looking SW

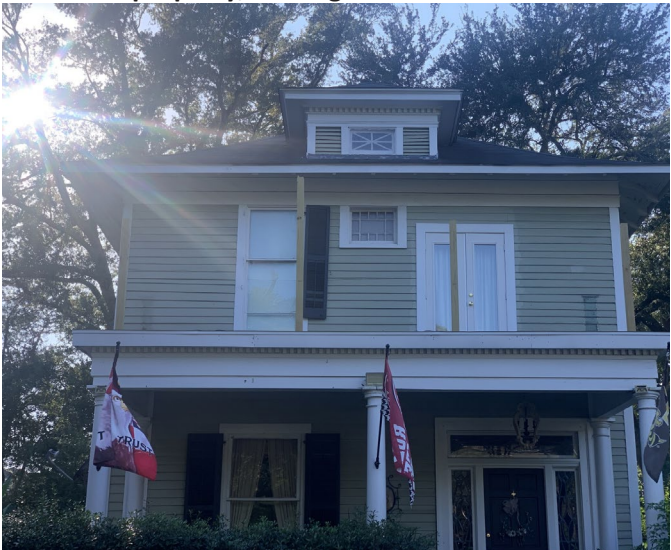
The *Guidelines* instruct that historic windows should only be replaced when they are beyond repair. (5.21) The *Guidelines* further specify, “A new window shall be installed in such a manner as to fit within the original window opening” and should match in light configuration, detail and material. (5.20) The windows on the façade appear to be the original windows or a match of the original. The newly installed double doors clearly do not fit the original window opening and disrupt the historic fenestration rhythm across the façade, which is contrary to the *Guidelines’* directive to maintain historic façades. (5.3) The applicant has not indicated the material of the replacement doors.

3. Detail of work on second-story façade, looking W

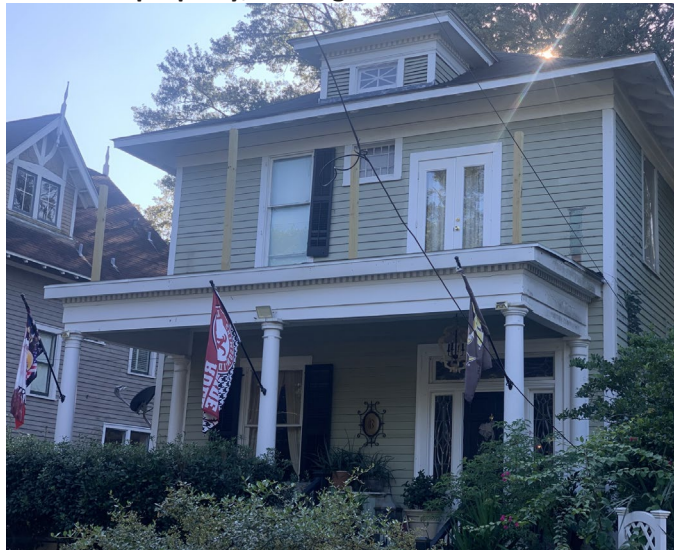
4. View of work on second-story façade, looking SW
