Agenda Item #6

Application 2024-58-CA

301 McDonald Avenue

Replace 4 windows on north elevation with vinyl windows not matching the originals in dimensions or light configuration.

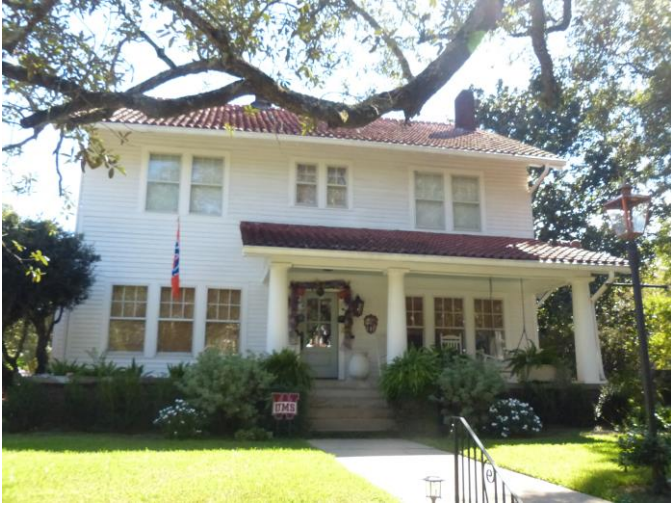
1. View east to front (west) elevation

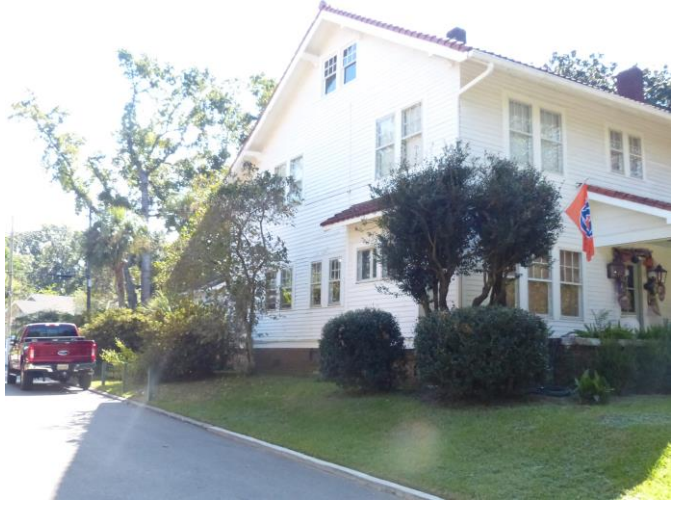
2. View southeast to north (left) elevation; far western end of Church Street in foreground

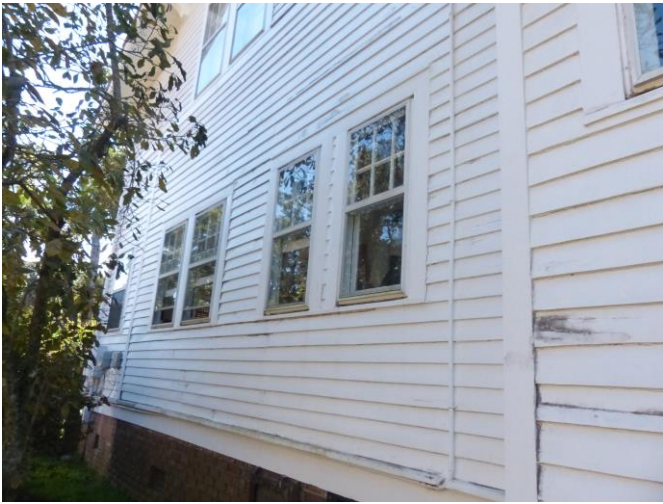
3. View east-southeast to subject windows

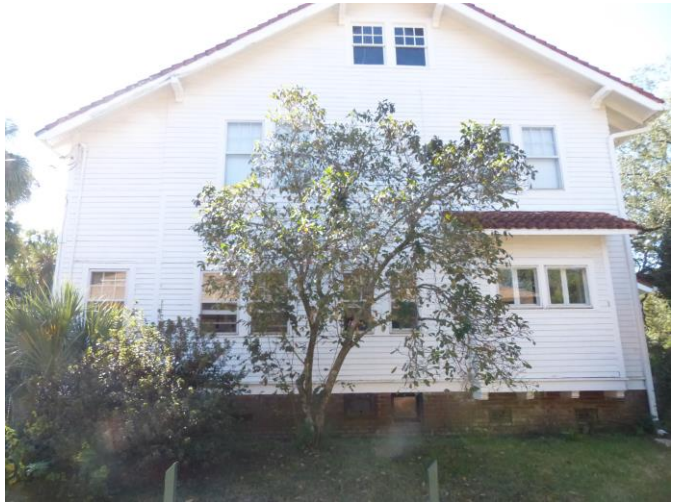
The two sets of windows proposed for replacement are slightly different in light pattern and size. The existing windows have a six-over-one light pattern, whereas the proposed replacements are four-over-one. The existing easternmost windows measure 30" wide by 40" high. The proposed replacement windows would be 4" shorter and 6" narrower. The windows would maintain the existing lintel height with shortening on the bottom. The westernmost pair of windows are 24" wide and 40" high; the replacement windows would be of identical width but 4" shorter. The lintel height also would be retained here, with the shortening on the bottom. In order for the new windows to blend into the elevation, the entire north elevation would be resided in kind.

4. North elevation; subject windows at 1st floor center

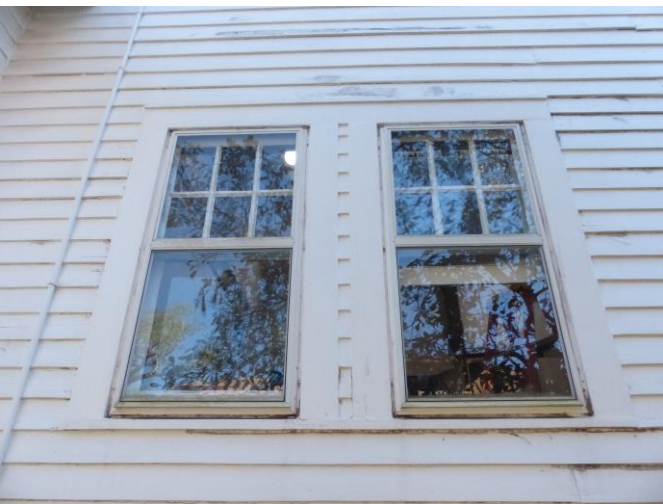
The *Guidelines* instruct that historic materials should be removed and replaced only when they are beyond reasonable repair, which has not been shown to be the circumstance in this case. (5.4) The the *Guidelines* do not specifically address the presented circumstance, a proposal to replace the existing windows with shorter windows to accommodate new cabinetry and counters in a kitchen renovation. However, the *Guidelines* clearly state that when replacement windows are proposed, "the new windows shall match the existing as per location, framing, and light configuration." (5.21) The proposed replacement windows would be in the same location, but they would not match the existing in light configuration. Furthermore, vinyl is considered an unacceptable window material for contributing properties within Mobile's historic districts. (5.22)

5. Detail: westernmost pair of windows proposed for replacement

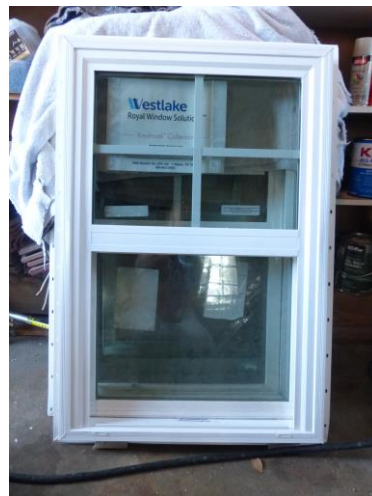
6. example of proposed replacement window

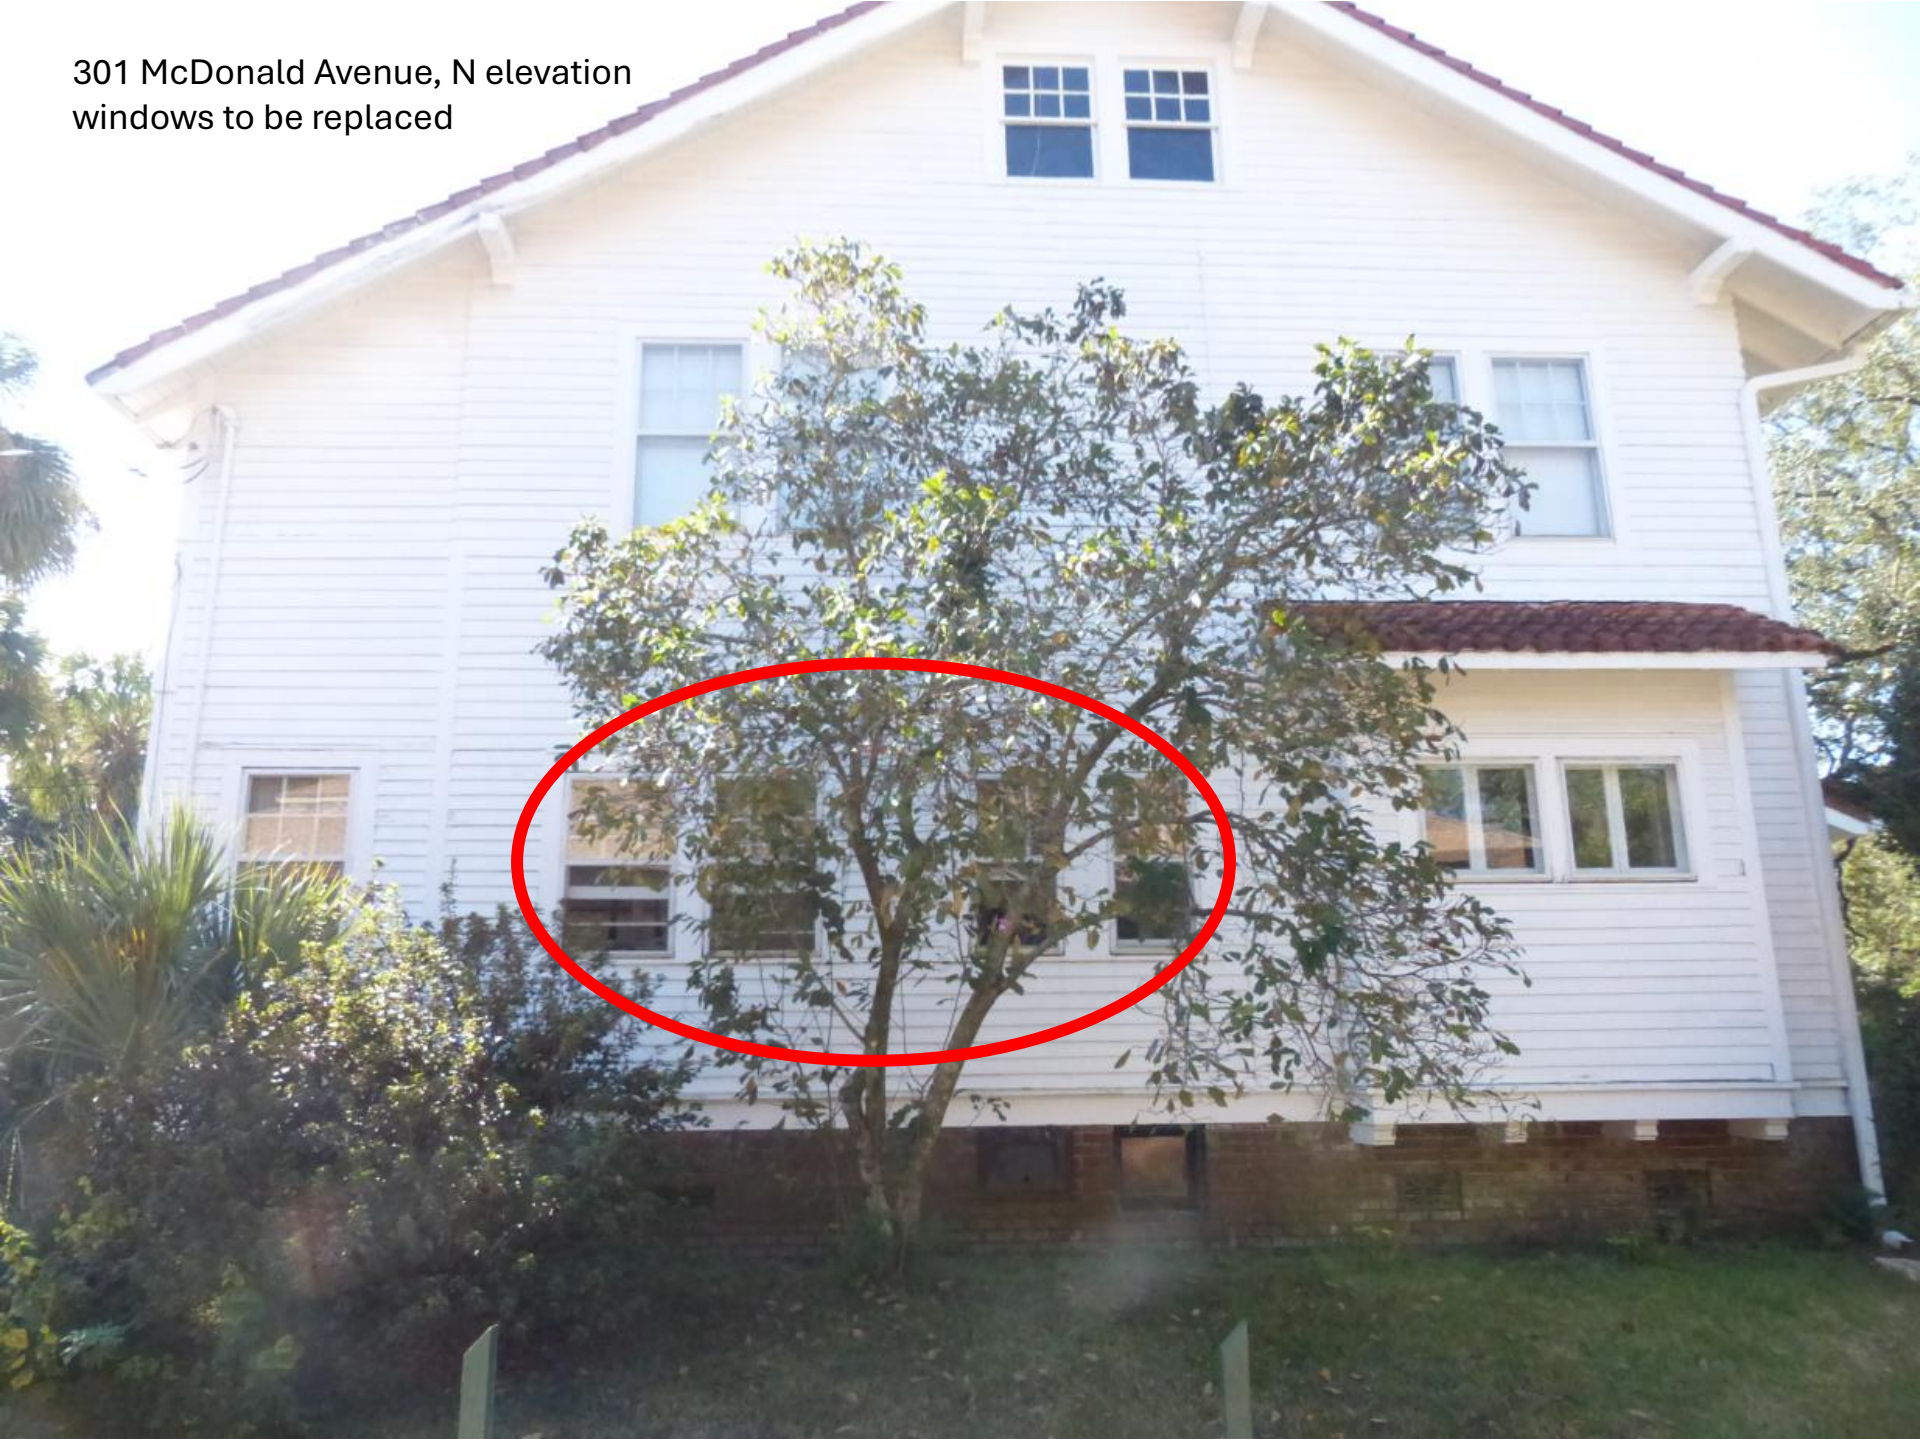
301 McDonald Avenue, N elevation
windows to be replaced

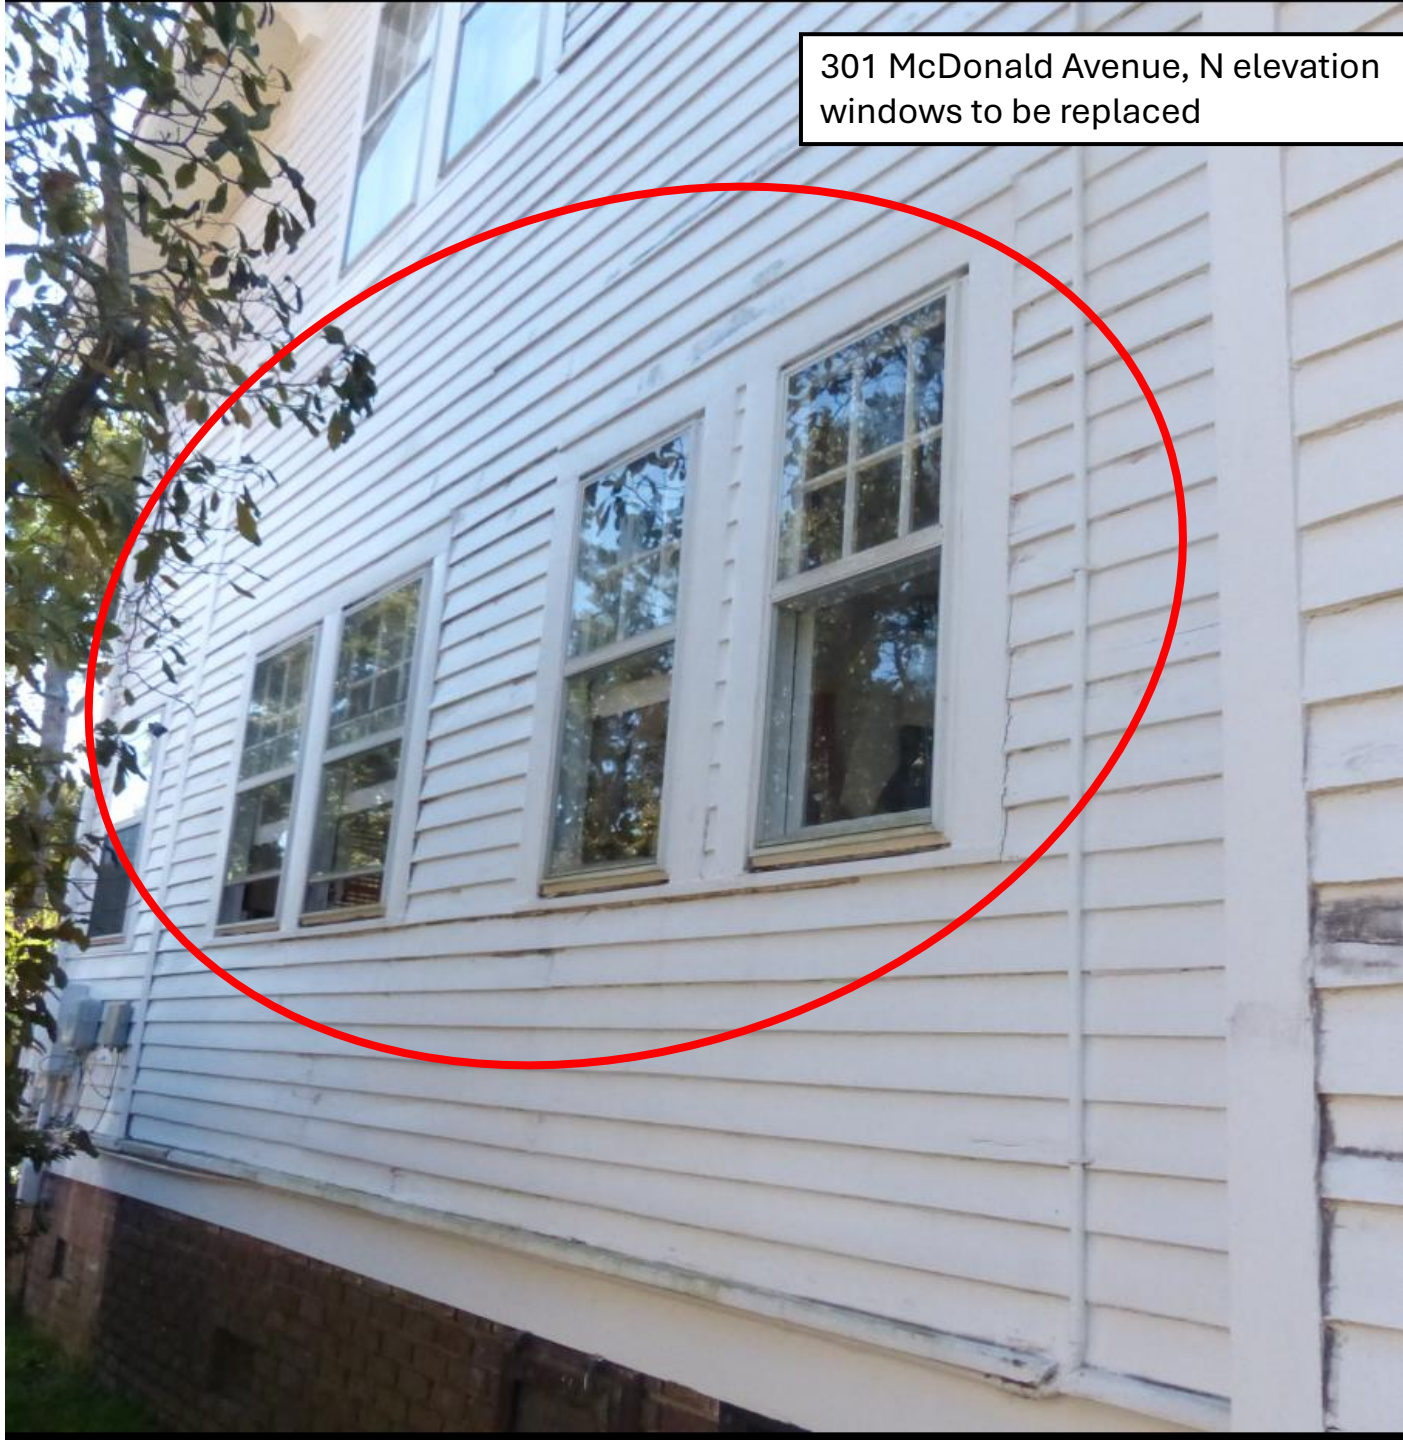
301 McDonald Avenue, N elevation
windows to be replaced
