Agenda Item #2

Application 2024-13-CA

30 Hannon Avenue

Revise fenestration plan for south elevation and east entry door.

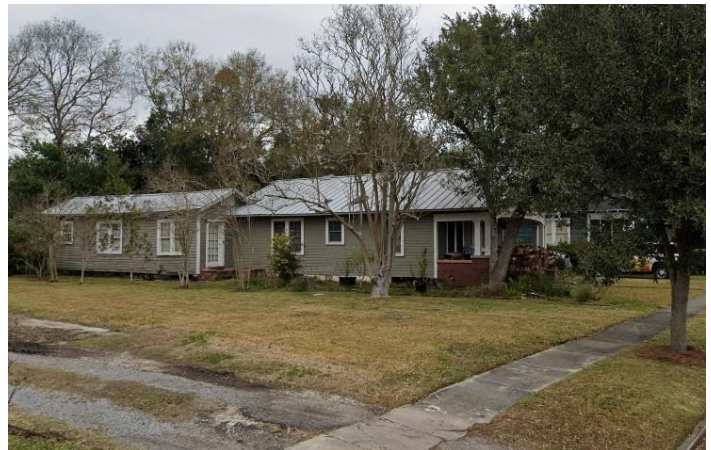
- a. Remove all windows on the south elevation (five windows) and replace with one four-light transom wood window measuring 40” wide by 12” high, located on the east end of the elevation.
- b. Prior to removal, the fenestration on the south elevation was as follows (from east to west):
Small six-over-one window, a pair of six-over-one windows, a pair of six-over-one windows.

2. South elevation prior to alteration (Google Street View, 2019)

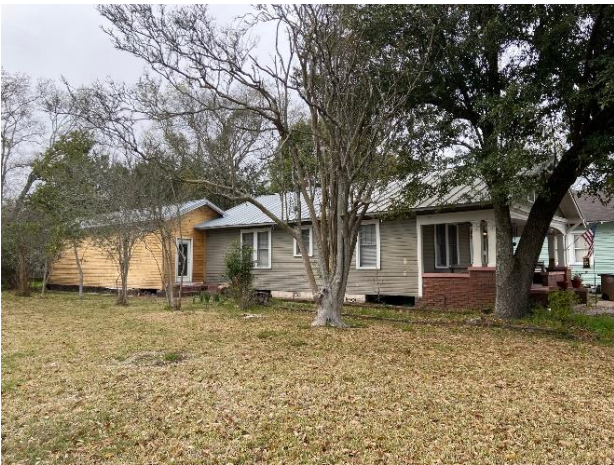
According to the *Guidelines*, replacement doors should align with the historic character of the building. Although a divided light or panel door would arguably be a more appropriate style, the single light replacement door on the

east elevation of the addition (see Photo 3) is not located on a primary façade and somewhat echoes the prairie style divided light entry door on the main façade. However, vinyl is not listed as an acceptable material for historic buildings. Further, the sliding glass door on the north elevation is not compatible with the historic character of the property or district. (5.15)

The original windows on the south elevation had been removed and replaced with 6" wood siding and one four-light transom wood window measuring 40" wide by 12" high, located on the upper east end of the elevation. The new plans propose a more traditional fenestration pattern which includes the installation of two fixed dummy windows represented as closed louvered shutters, and one six-over-one aluminum clad sash window. The new elevation drawings do not reflect the suggested changes for the east elevation's entry door. However, the applicant has submitted a manufacturer's cut sheet of a multi-light aluminum clad entry door.

3. South elevation, post alterations

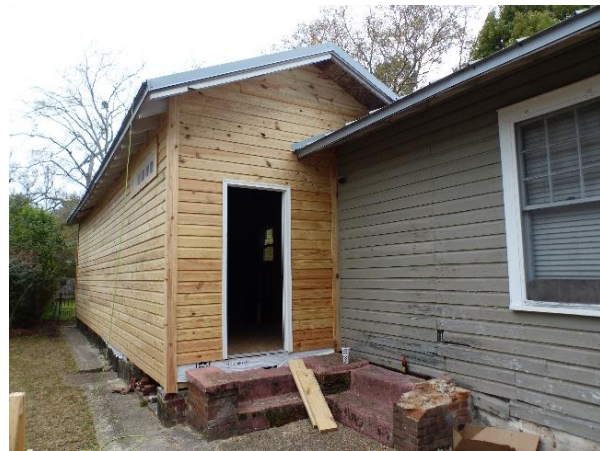
4. East and south elevations of addition

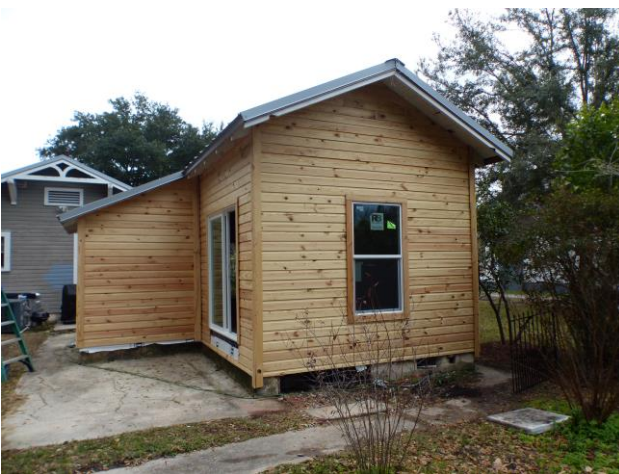
- a. Install one one-over-one window, centered on west elevation.
- b. The fenestration that existed prior to this installation is unknown.

5. View of west elevation of addition

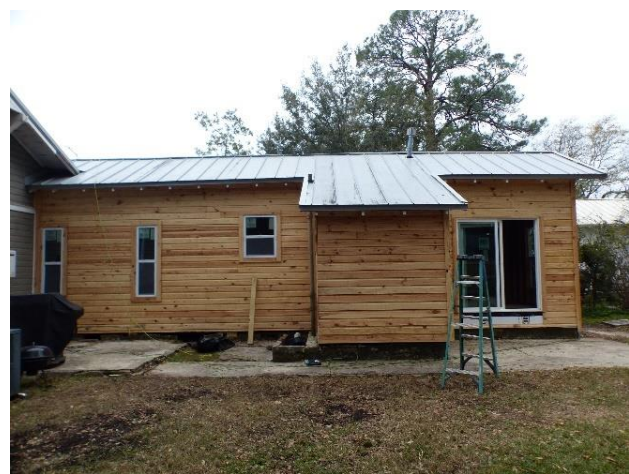
- a. Remove all fenestration on north elevation and replace with new vinyl fenestration.
- b. The fenestration pattern on the north elevation that existed prior to the alterations under review is unknown.
- c. The current fenestration is as follows:
One 1’-6” wide by 5’-0” high one-over-one window; one 1’-6” wide by 5’-0” high one-over-one window; one 2’-0” wide by 3’-0” high one-over-one window; one 6’-0” high sliding glass door.

6. View of north elevation

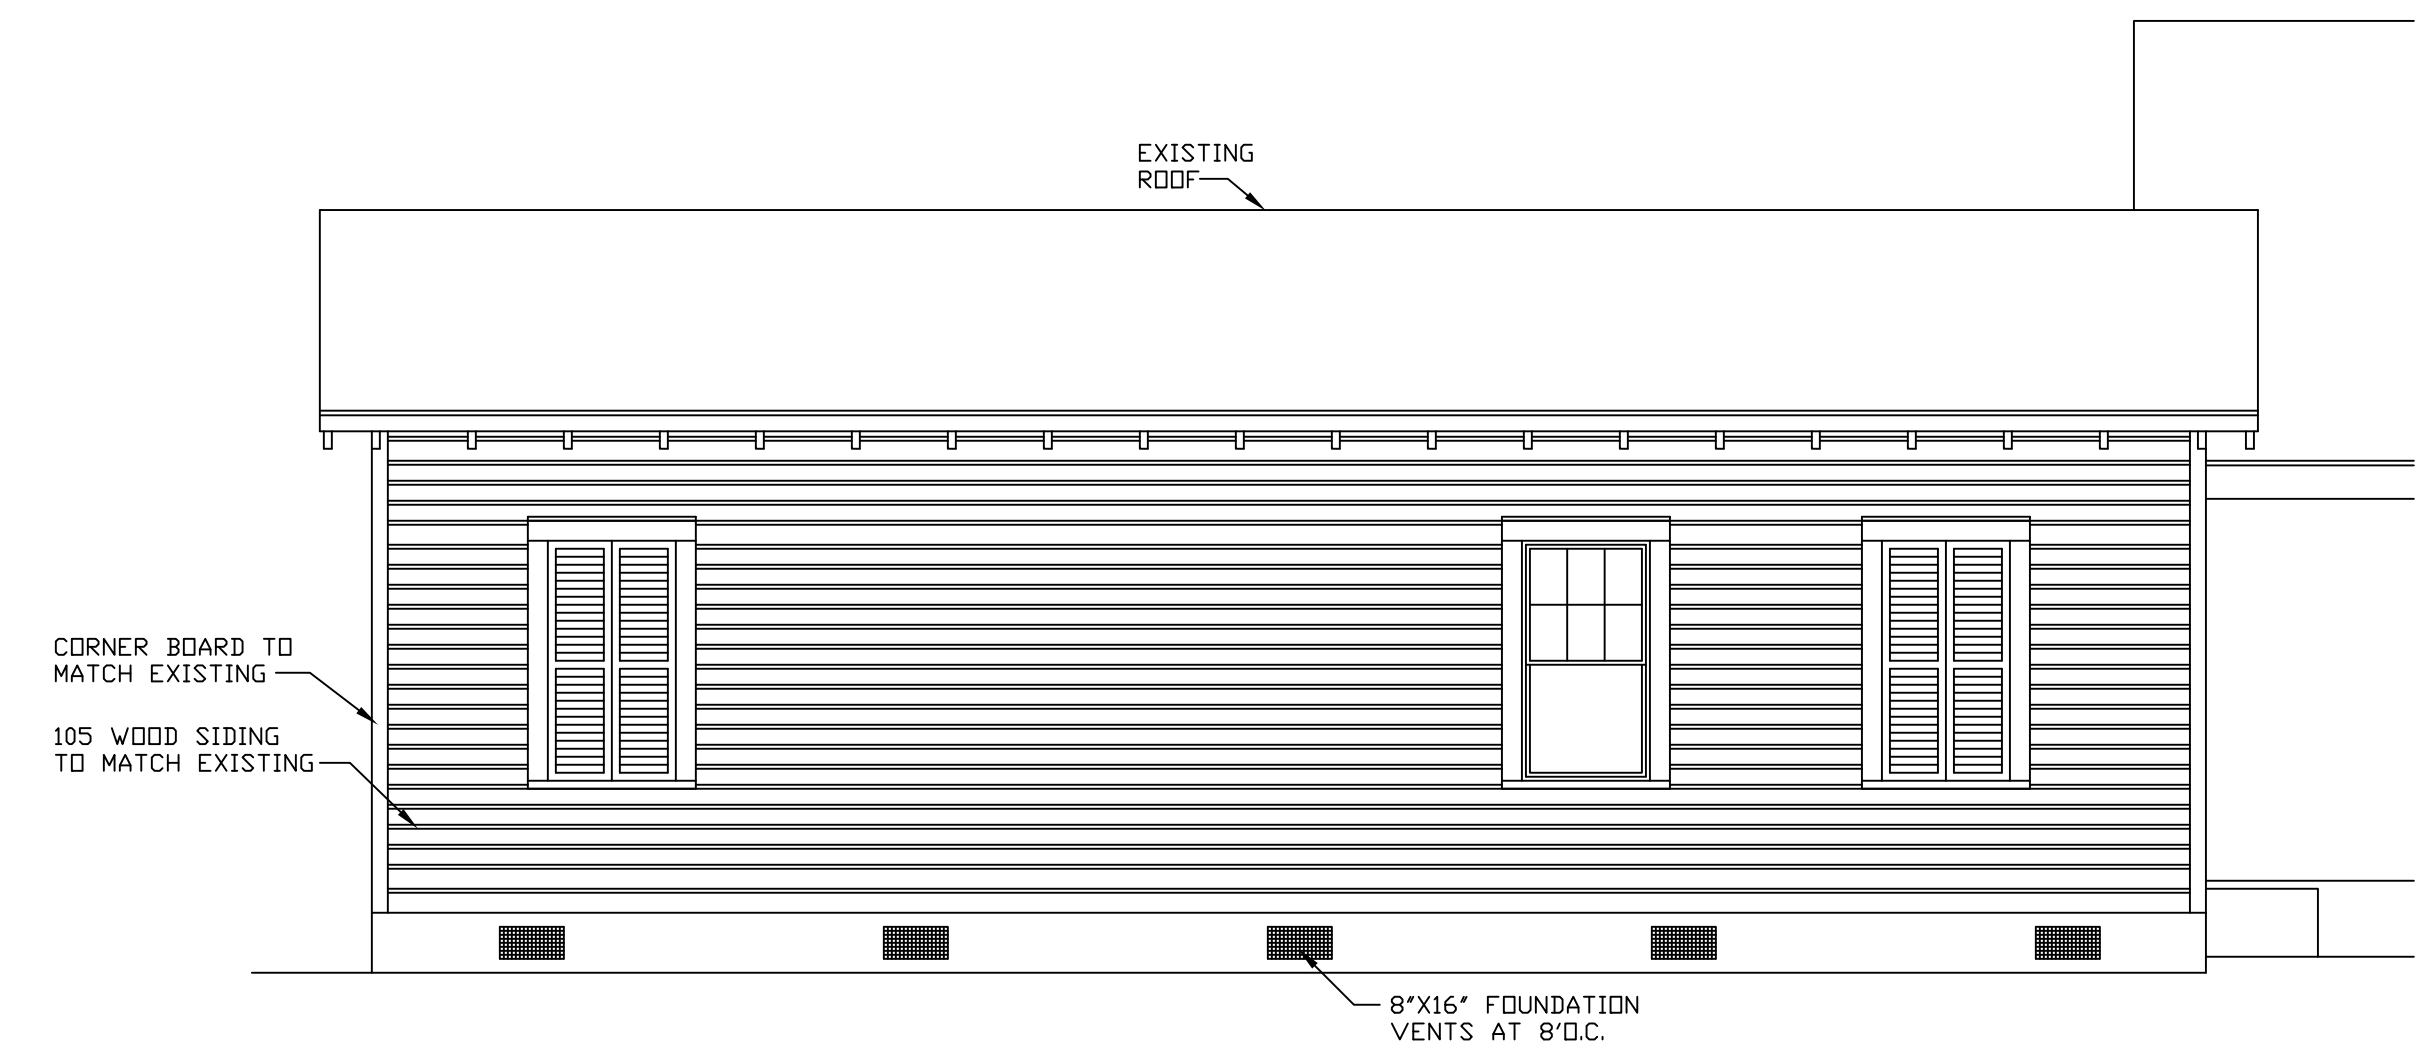
LEFT SIDE EXTERIOR ELEVATION

▲ REMOVED TRANSOM WINDOW AND INSTALLED FIXED SHUTTERS AND 3050 WINDOW AT LEFT SIDE EXTERIOR ELEVATION.

- b. Install two fixed dummy windows represented as closed louvered shutters, each measuring 3'-0" wide by 5'-0" high, one at each end of the elevation. The material for the dummy windows was not provided.
- c. Install one (1) 5'-0" high by 2'-8" wide six-over-one aluminum clad sash window in the east half of the elevation.
- d. The elevation would appear as follows (from west to east):
 Dummy window located on west end of the elevation; one six-over-one window and subsequent dummy window located on the east end of the elevation.
