Location: 61 N. Reed Avenue

Replace two front porch columns with fiberglass columns

Historic District: Old Dauphin Way

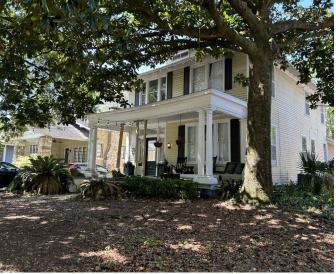
1. View of property, looking NE

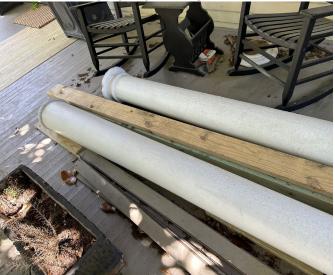
3. Existing paired columns

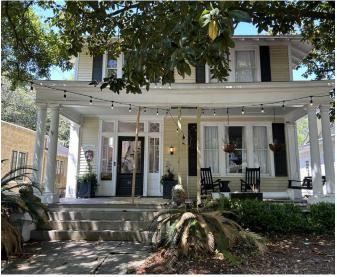
Location of removed columns, looking E 2.
