# Agenda Item #3

## Application 2024-45-CA

1555 Dauphin Street

Replace front porch columns with fiberglass columns of similar design

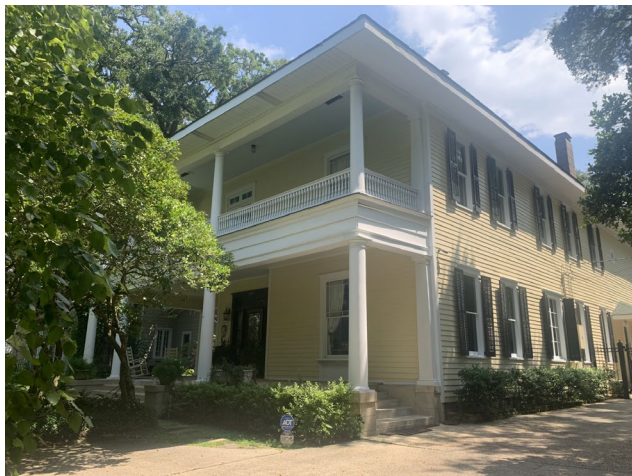
1. View of property looking southeast.

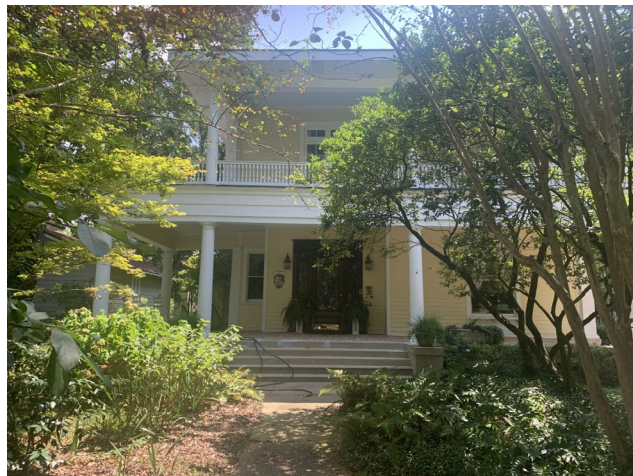
2. View of property looking south.

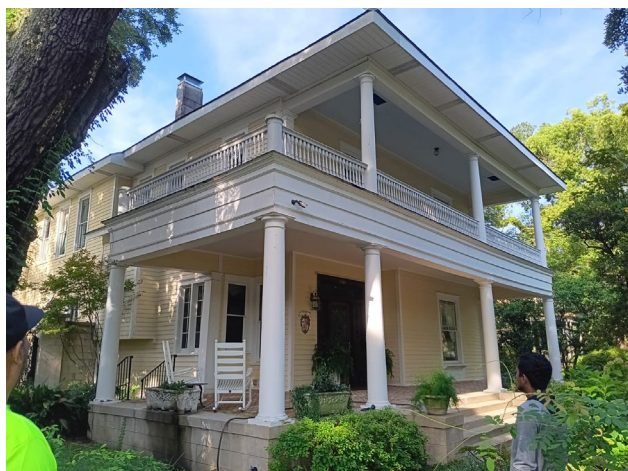
3. View of porch looking southwest.

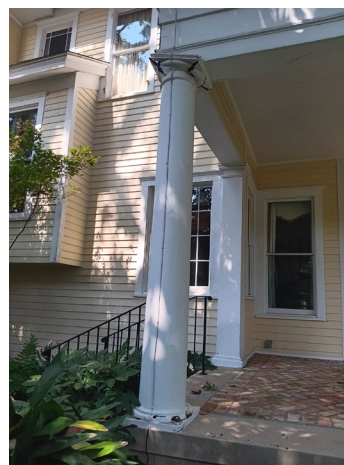
- The existing columns show signs of deterioration and loss of structural integrity.
- The proposed replacement columns generally match the dimensions of the existing with the exception of a lack of tapering seen on the existing columns.
- The fiberglass material of the proposed replacement columns could be considered an acceptable substitute material.

4. Details of column on southeast end of porch.

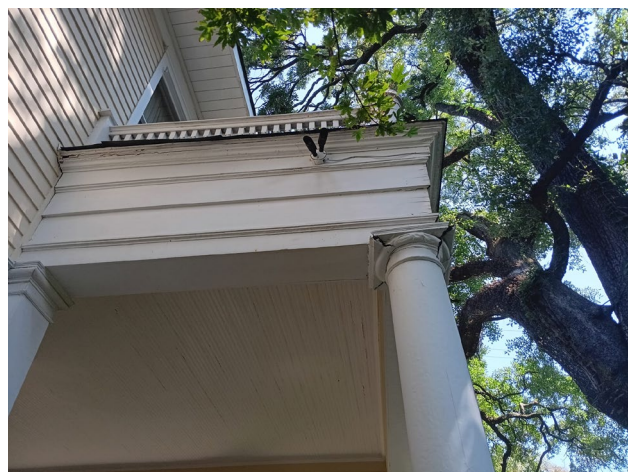
5. Detail of column cap on southeast end of porch.

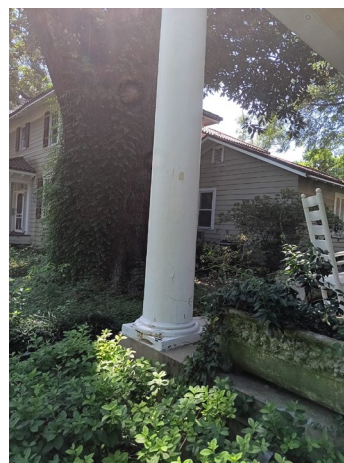
6. Detail of column on northeast end of porch.
