Agenda Item #1

Application 2024-32-CA

156 S. Monterey Street

Replace windows on east (façade), north, and south elevations. Alter fenestration pattern on rear sunroom elevations.

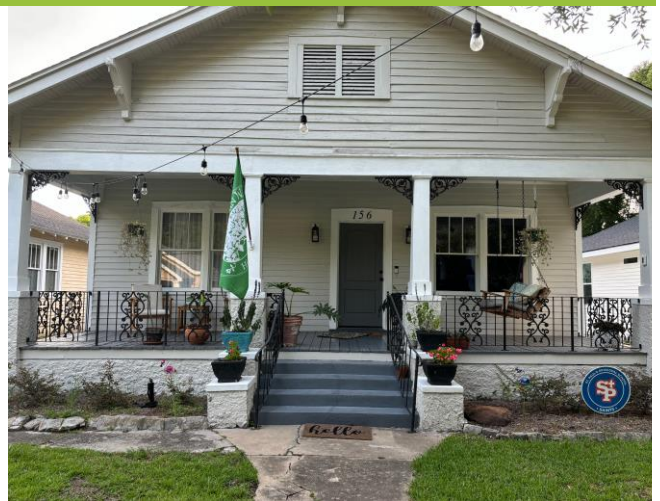
2. East façade, looking west. The four façade windows would be replaced with new wood sashes.

1. Replace all four windows on east façade.
Replacement windows would be wood, would fit existing openings, and would retain a three-over-one lite configuration.

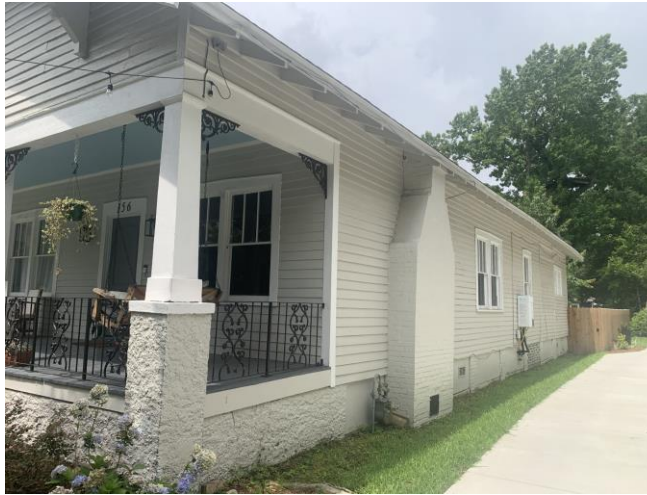
3. View of north elevation, looking southwest. All side elevation windows would be replaced with vinyl sashes.

2. Replace all windows on north and south elevations.
Replacement windows would be vinyl, would fit existing window openings, and would retain a three-over-one lite configuration.

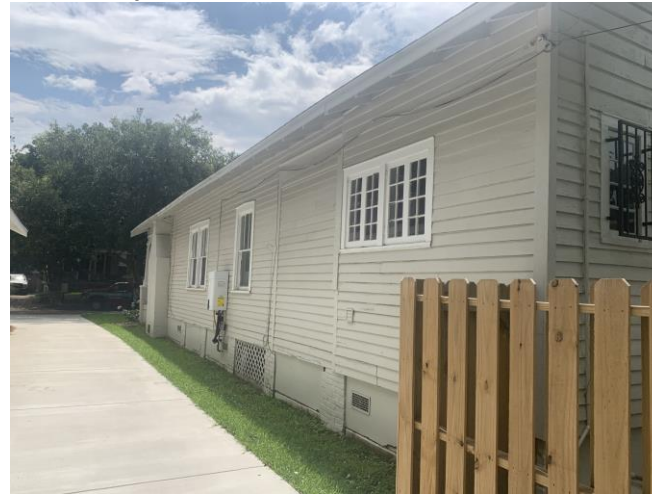
4. View of north elevation, looking southeast (note the evidence of a rear addition). All side elevation windows would be replaced with vinyl sashes.

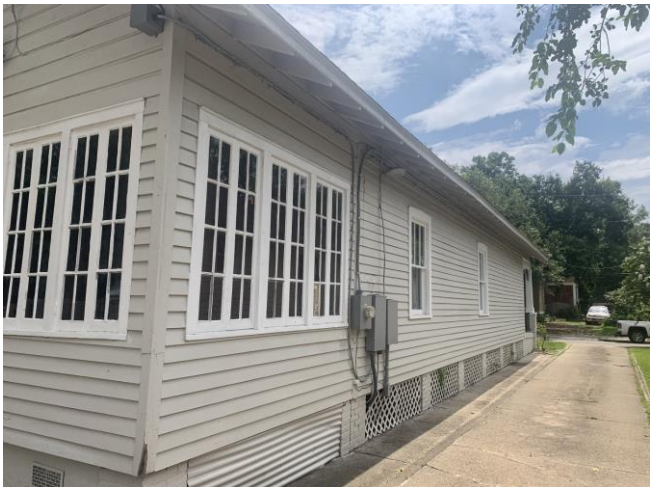
5. View of south elevation, looking northeast. All side elevation windows would be replaced with vinyl (except 3 sunroom casement windows in foreground).

The existing rear sunroom is a later addition and not original to the house. The sunroom currently includes ten (10) casement windows, seven (7) along its west elevation and three (3) along its south elevation. The application proposes the removal of the three (3) casement windows on the south elevation. Wood lap siding, which matches the existing, would fill the opening. The proposed fenestration alterations to the sunroom's west elevation would include the replacement of the first three (3) casement windows (from north to south) and the removal of the subsequent four (4). Two (2) eight-lite fixed sash windows, measuring 18" wide by 36" high, would be installed in place of the removed casement windows. These two windows would match the one existing fixed sash located on the north end of the rear elevation. As stated above, the *Guidelines* call for preservation and repair of windows over replacement and removal. Although the sunroom is an addition, it is over fifty (50) years old and has attained significance in its own right. Also to be considered in review of this application is the rear location of the addition (with the west elevation not visible from the street). (5.20,5.21) The exact alteration and choice of materials have not been finalized for this portion of the project, as the applicant wishes to seek advice from the Board.

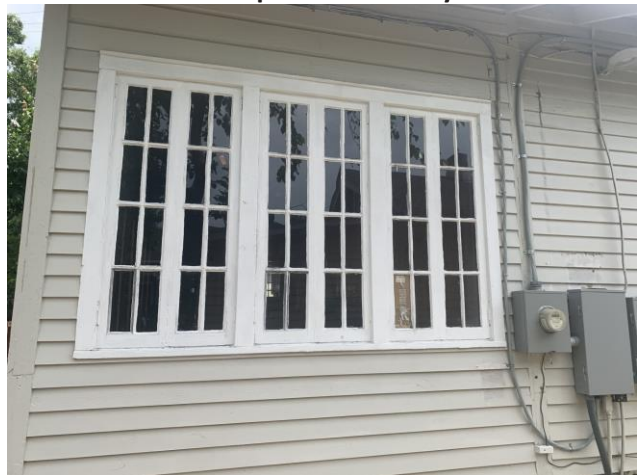
6. Detail of sunroom windows to be removed on south elevation.

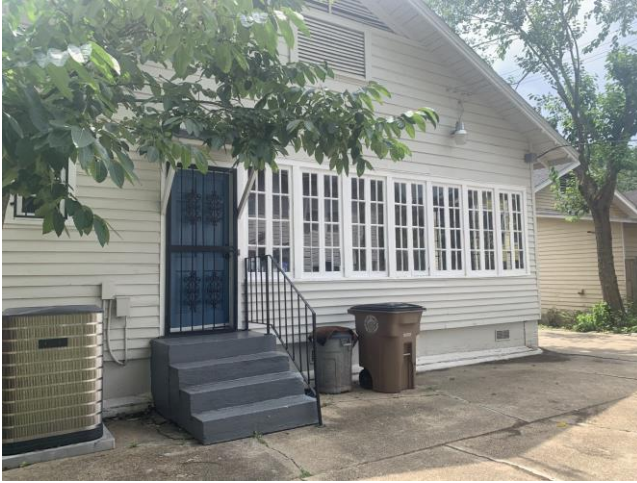
7. View of west (rear) elevation, looking southeast.

- b. The fenestration pattern on the west sunroom elevation (south end of the rear elevation) would be altered from seven (7) casement windows to three (3), with the replacement of the first three (3) windows from north to south, and the removal of the four southernmost windows.

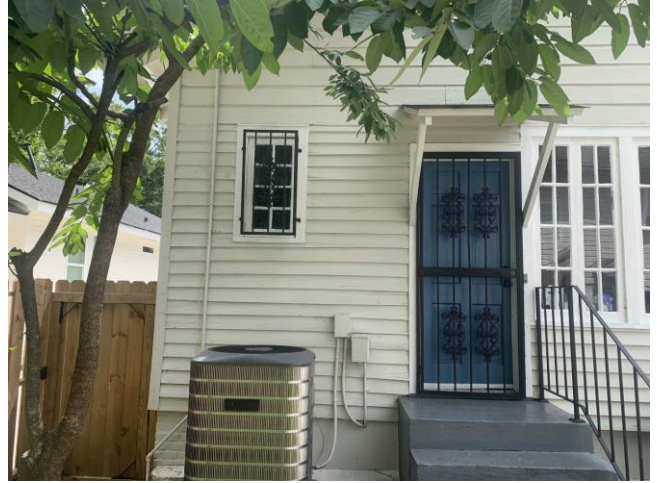
8. View of eight-lite fixed on west elevation. This window would remain. The two new eight-light windows proposed for the south end of the rear elevation would match this window.
