Agenda Item #2

Application 2024-29-CA

7 Hannon Avenue

Remove and replace existing siding with fiber cement lap siding. Replace windows on all elevations except those on the façade and two windows on rear addition.

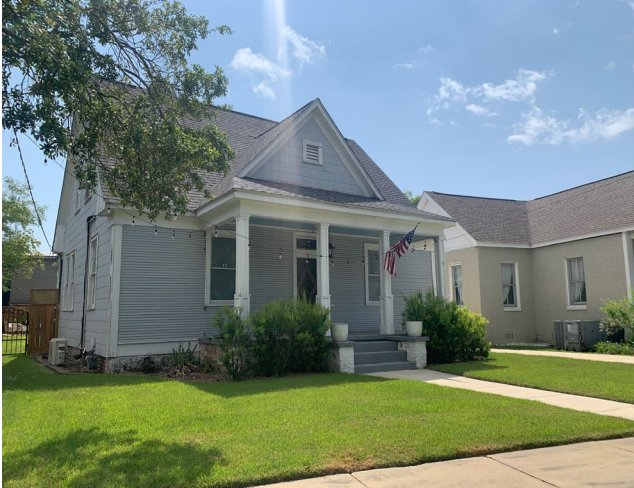
1. View of west façade, looking east. Note wood drop siding on façade and asbestos siding in center gable.

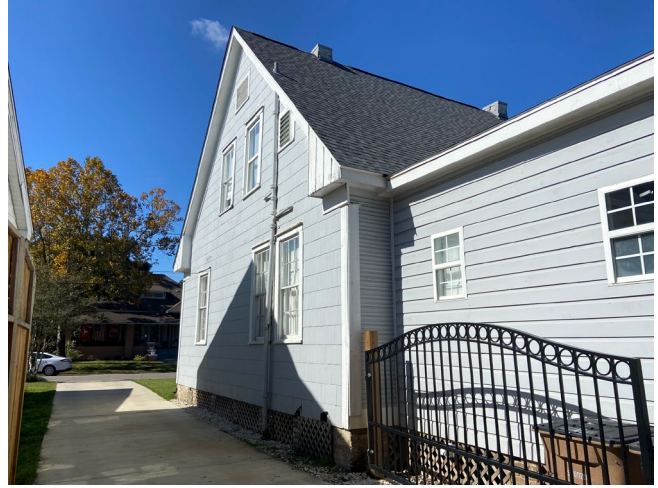
2. View of south elevation, looking northwest. Note asbestos siding on original block and fiber cement on one-story rear addition.

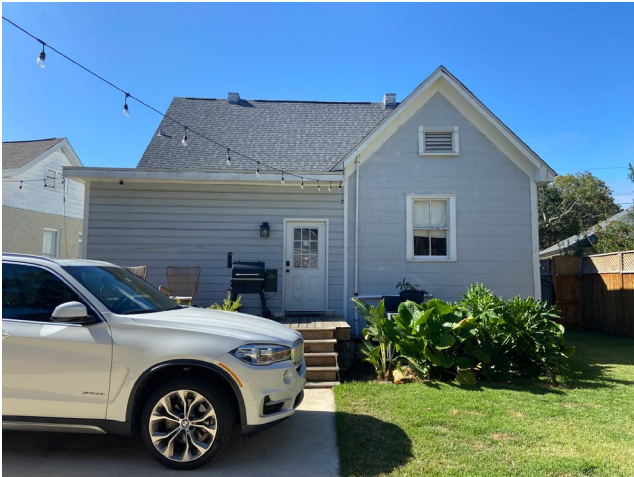
3. View of rear (east) elevation, looking west. Note fiber cement siding on flat roof portion and asbestos siding on gable cross-wing.

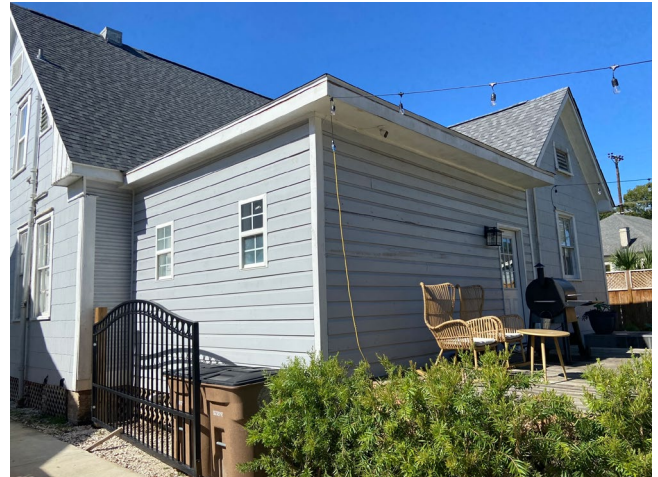
4. View of windows which would remain extant on rear addition, looking northwest

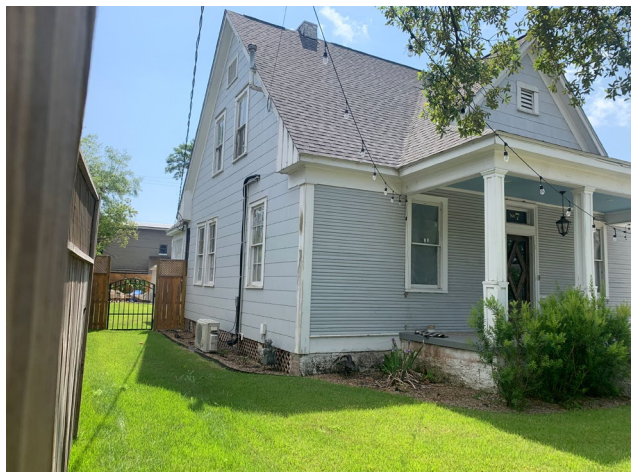
5. View of north elevation, looking southeast. Note mix of asbestos siding and wood drop siding.

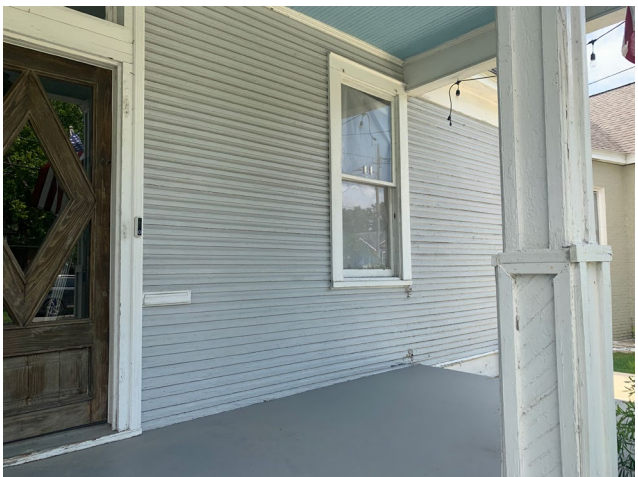
6. View of façade siding
